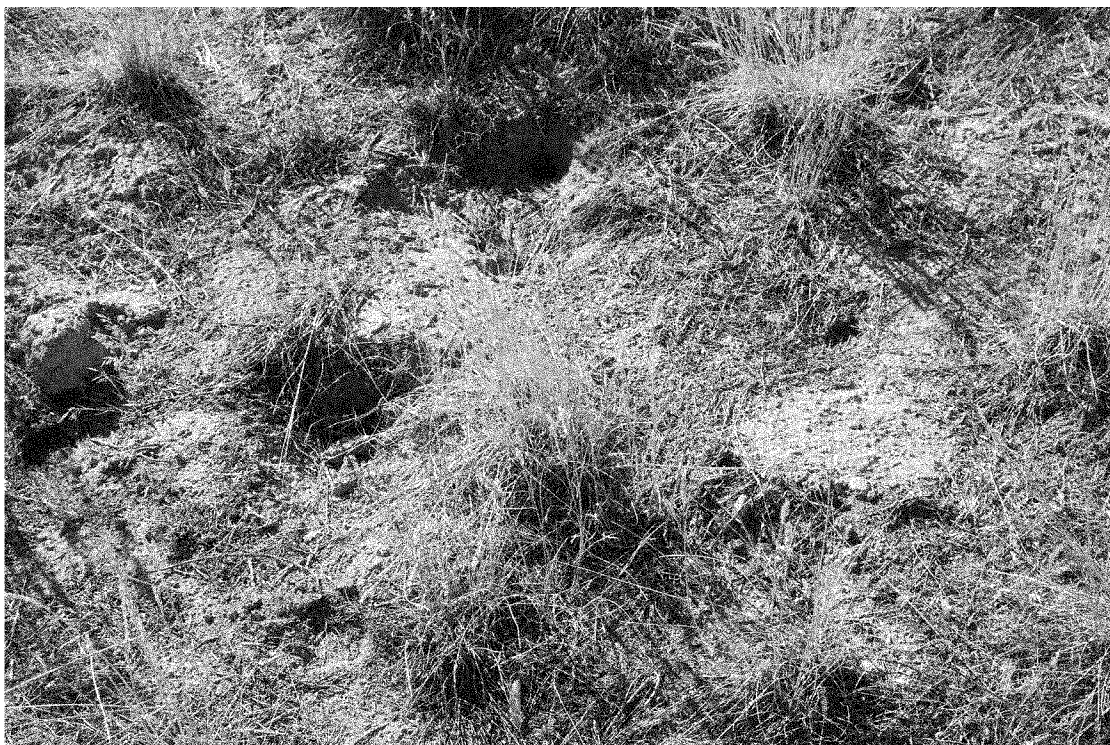
Figure B-6. Animal intrusion at CFA-01 Landfill I (PD020605-22).

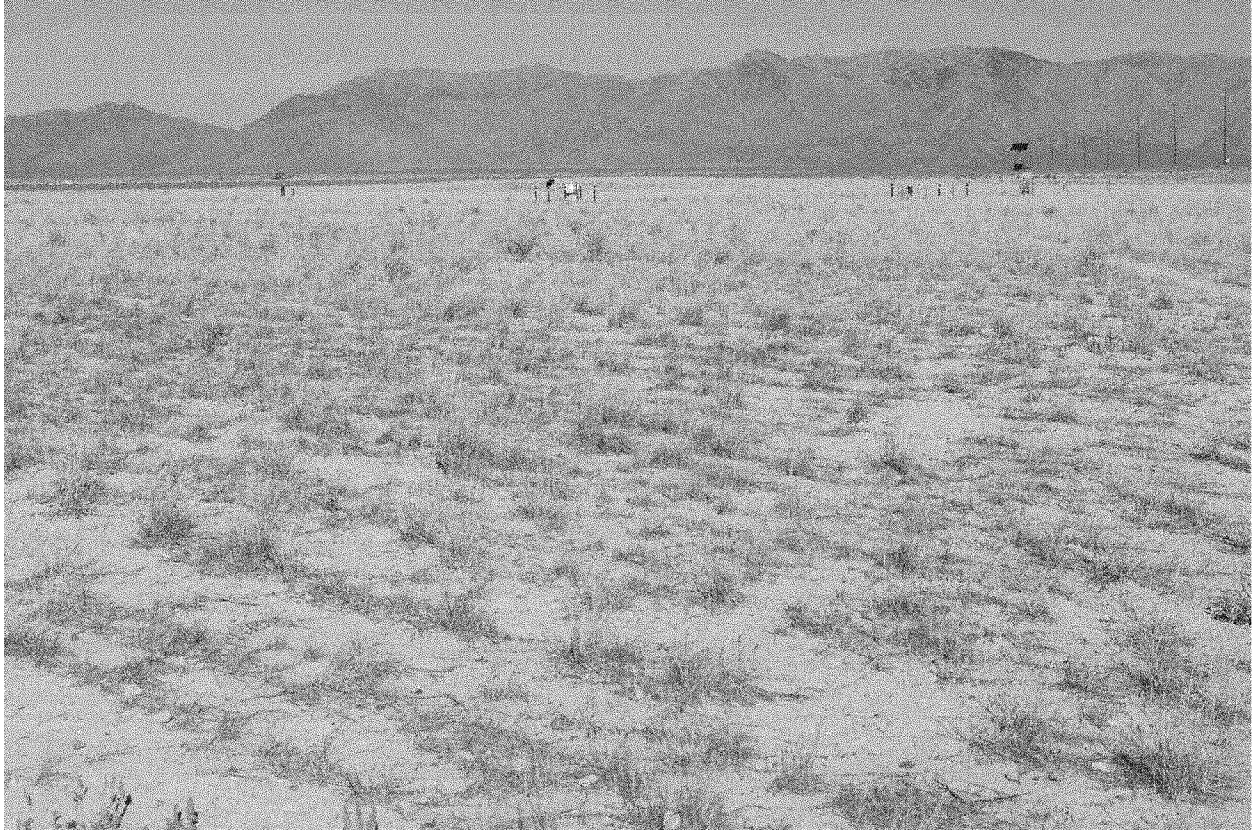
Figure B-8. View of CFA-02 Landfill II looking northwest, with sparse vegetation in foreground and moisture monitoring network in the background (PD020605-05).

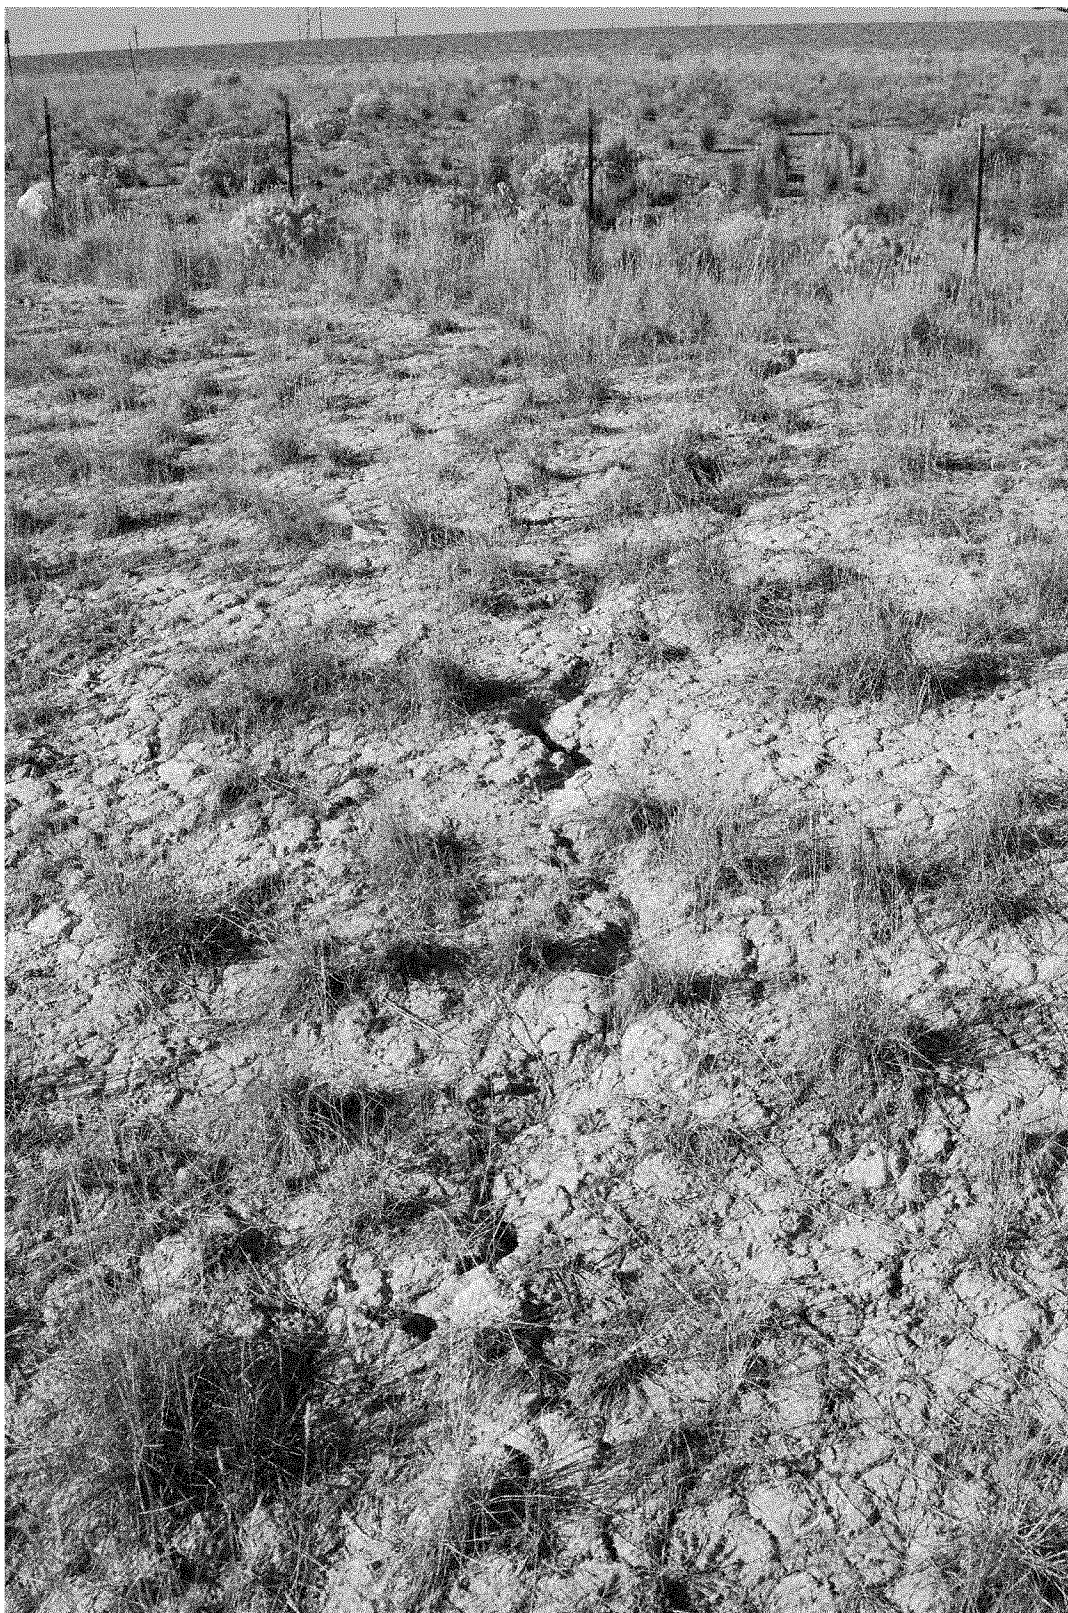
Figure B-9. Erosion rill at CFA-02 Landfill II, northwest portion of landfill (PD020605-07).

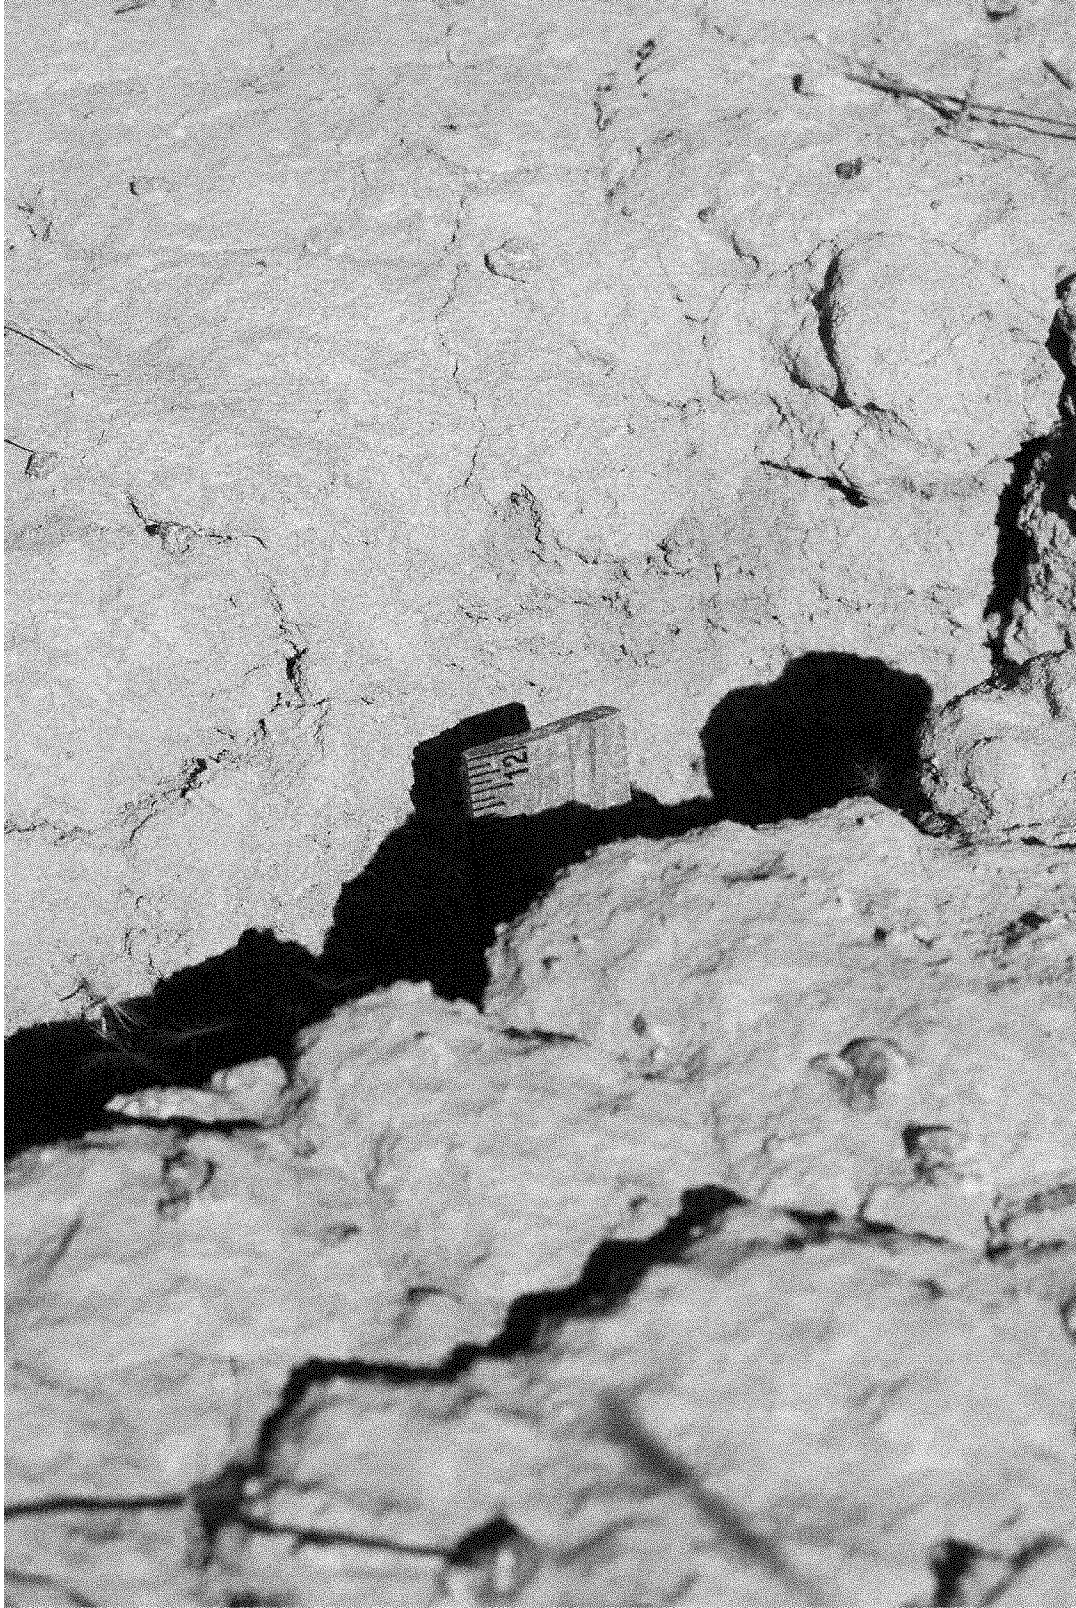
Figure B-10. Detail of erosion rill in northwest corner of CFA-02 Landfill II showing depth of rill (PD020605-10).
